NATIONAL REGISTER OF HISTORIC PLACES
REGISTRATION FORM

historic name: North Entrance Road Historic District

North Entrance Road Historic District
Park County, Montana and Park County, Wyoming

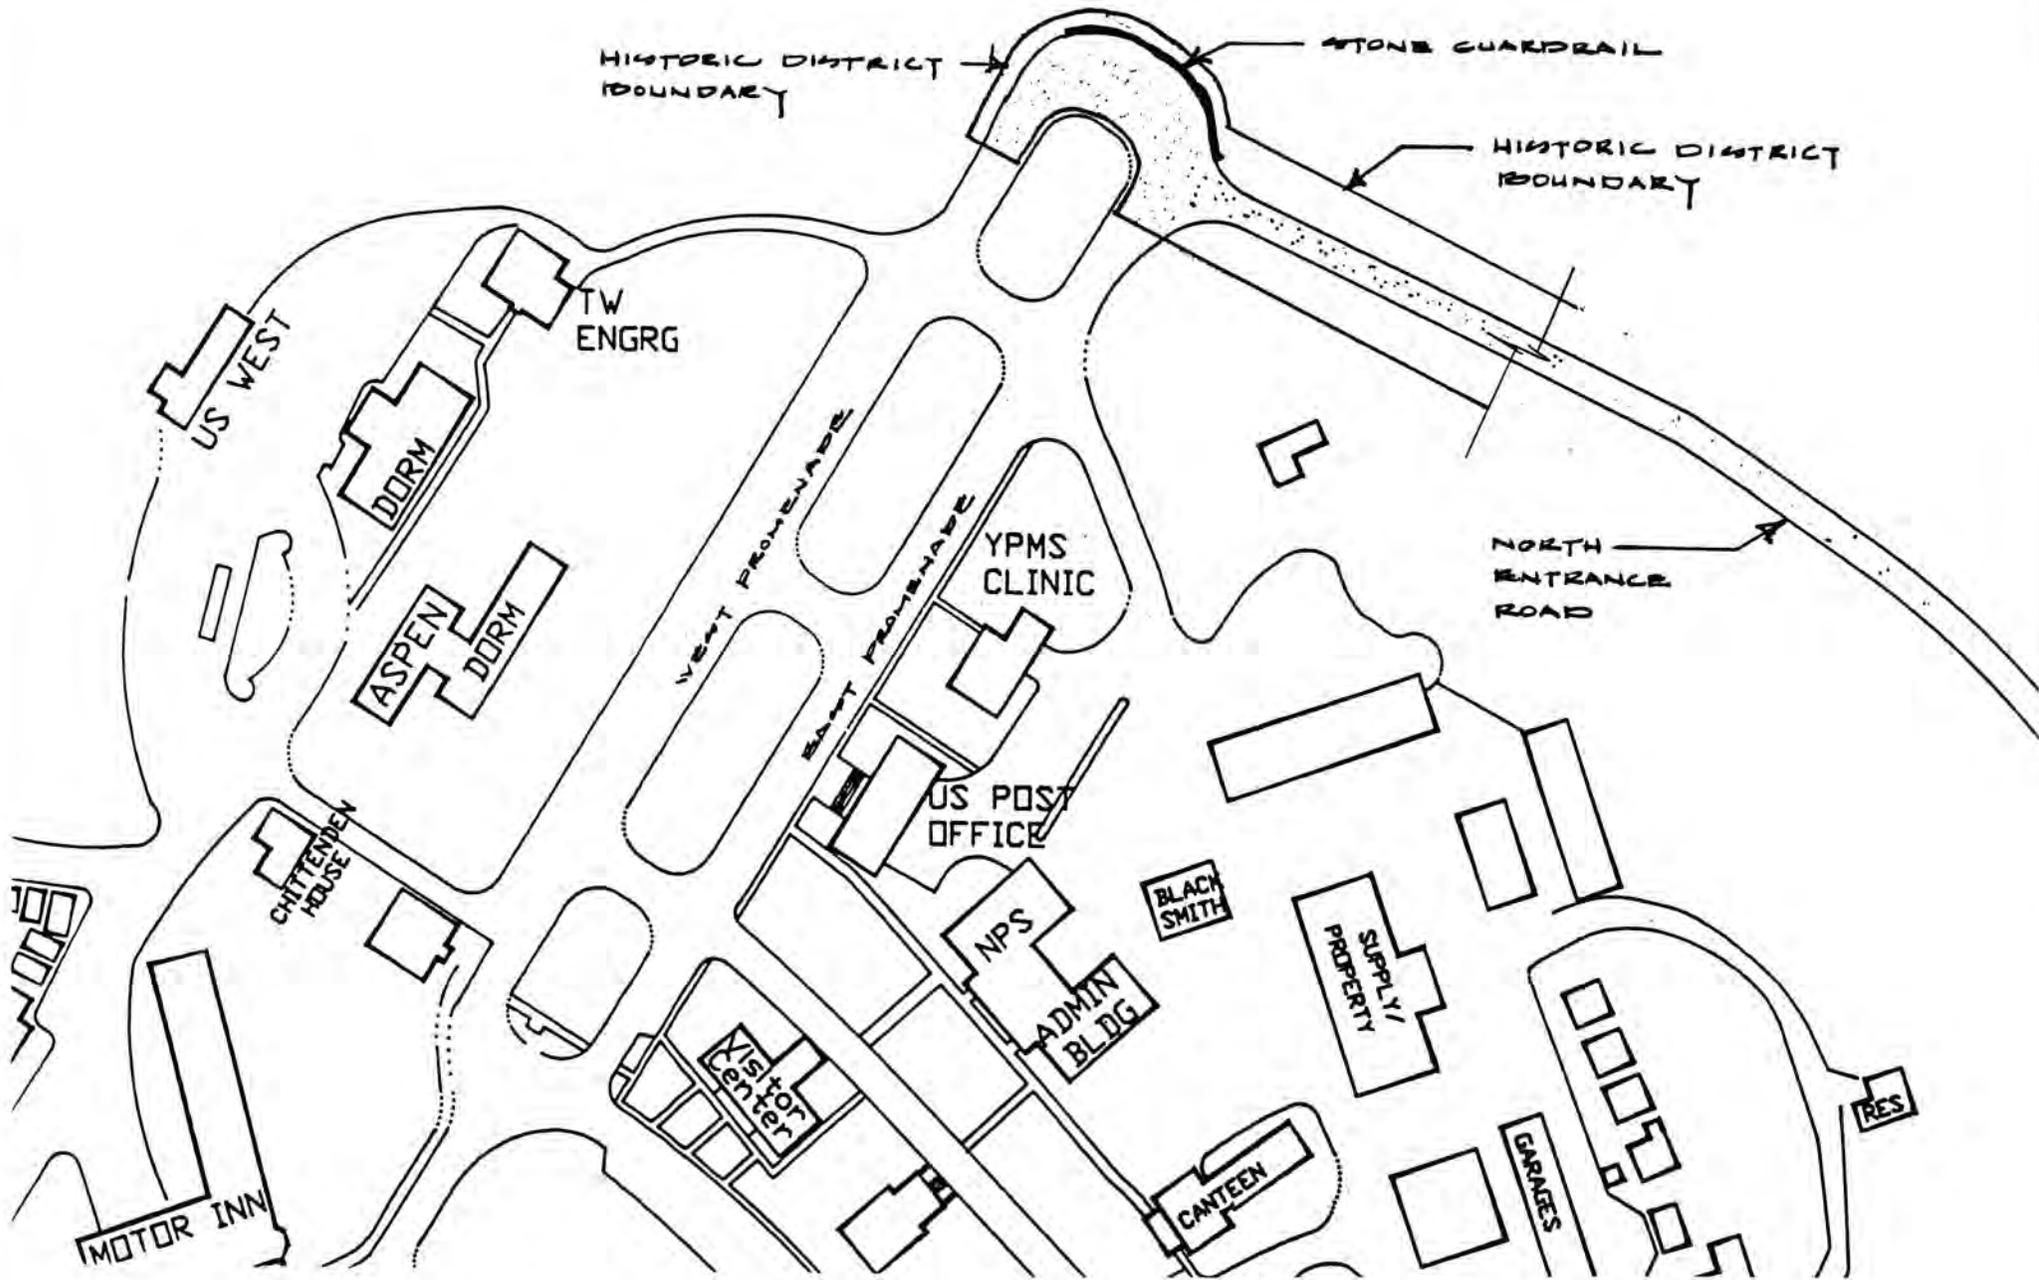
SOUTHERN TERMINUS
NORTH ENTRANCE ROAD HISTORIC DISTRICT
YELLOWSTONE NATIONAL PARK

Once the boundary reaches the northeastern end of the Mammoth Hot Springs promenade, continue the north road boundary to within 5 feet of the stone guardrail; then follow 5 feet behind the guardrail as it curves to form a pullout. Continue the natural extension of the boundary on the south side of the road across the east promenade drive until it intersects the median strip's concrete curb; turn northeast, northwest, then southwest, following the curb to a point opposite where the south boundary intersects the curb. Then turn northwest, crossing the west promenade drive to a point five feet past the road shoulder. From this point turn northeast and proceed 5 feet from the shoulder until the boundary intersects the line on the north side of the road.
